Our Ref: GBW Number 18-03619 Issue 1 Date 20/03/2018 Page 1 of 4

T I MIDWOOD & COMPANY LIMITED
Green Lane
Wardle
Nantwich
Cheshire
CW5 6BJ

SALT SPRAY TESTING OF ZINC PLATED SCREW SAMPLES

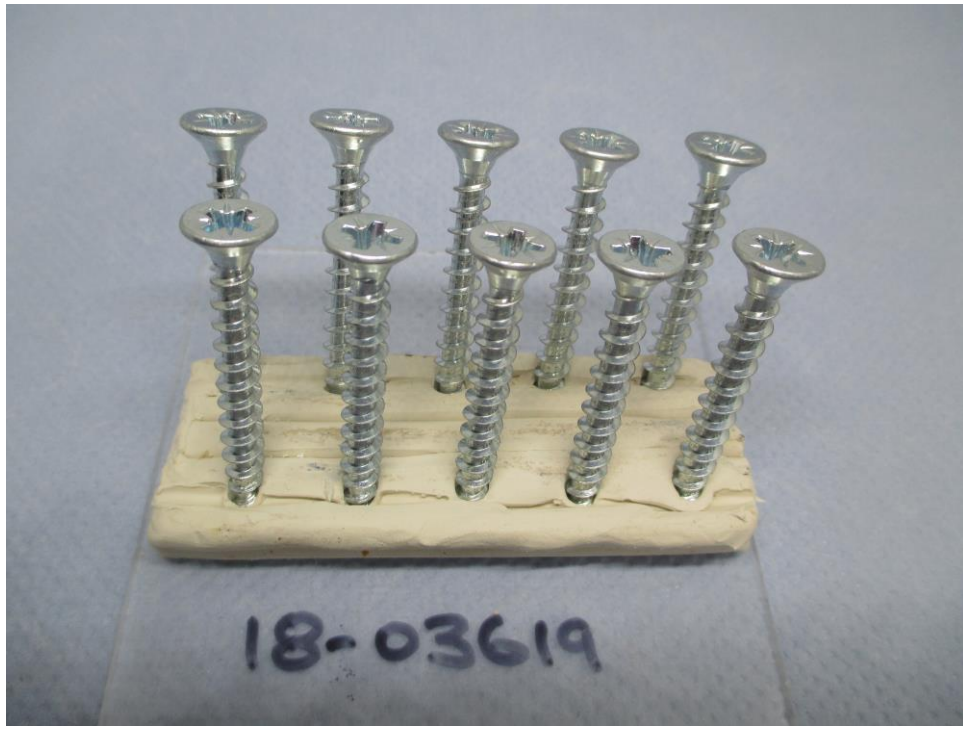
The photograph in fig 1 is showing the as received condition of samples prior to test, the samples were exposed to a neutral 5% Salt Spray, for a test period of 120 hours, with examinations after every 24 hours revealed the following observations:-

FIG 1: The photograph is showing the condition of the Timco Solo Woodscrew Samples prior to salt spray test

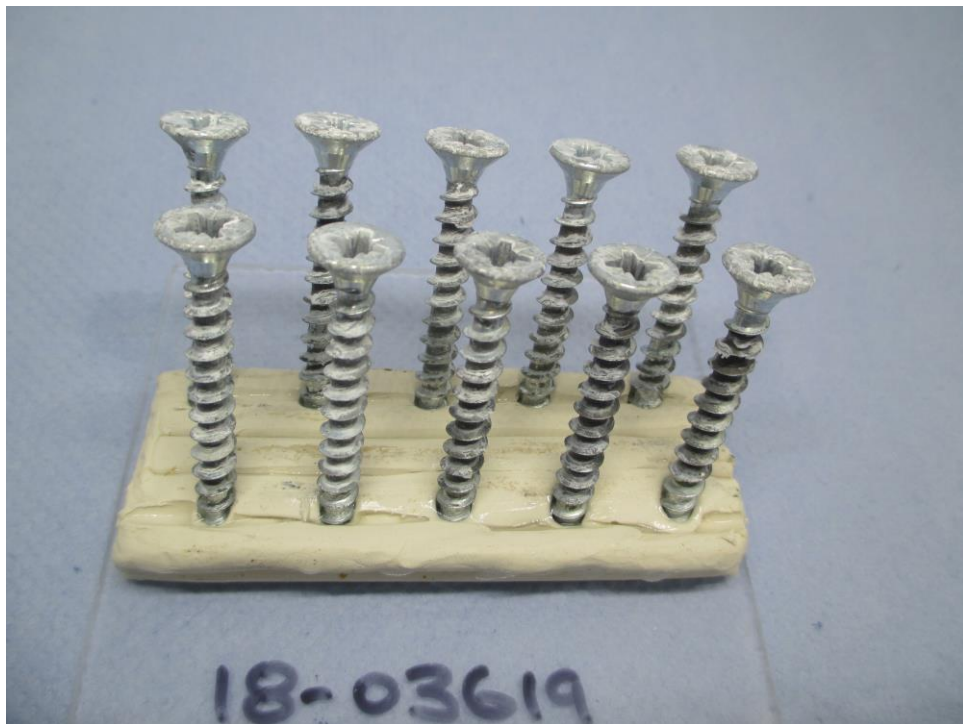
The samples showed evidence of total white corrosion product, (see photograph after 24 hours).

FIG 2: The photograph is showing the condition of the Timco Solo Woodscrew Samples after 24 hours salt spray test

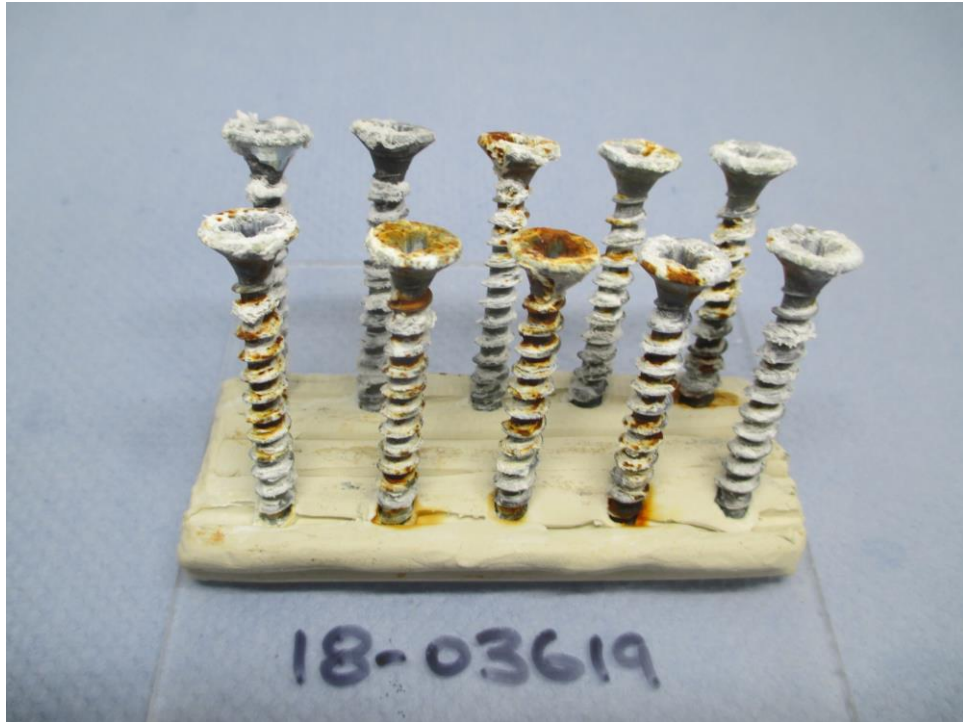
The samples showed evidence of very slight to significant red ferrous corrosion on seven samples, the other samples showed total white corrosion product, the samples were removed from test, (see photograph after 120 hours).

The Timco Solo Woodscrew Samples tested, first showed evidence of the formation of red ferrous corrosion after 120 hours salt spray test.

FIG 3: The photograph is showing the condition of the Timco Solo Woodscrew Samples after 120 hours salt spray test
